On-Orbit Maintenance of a Short Duration Mission: Space Technology 5

Alexander C. Calder
Senior Computer Scientist

November 13, 2008

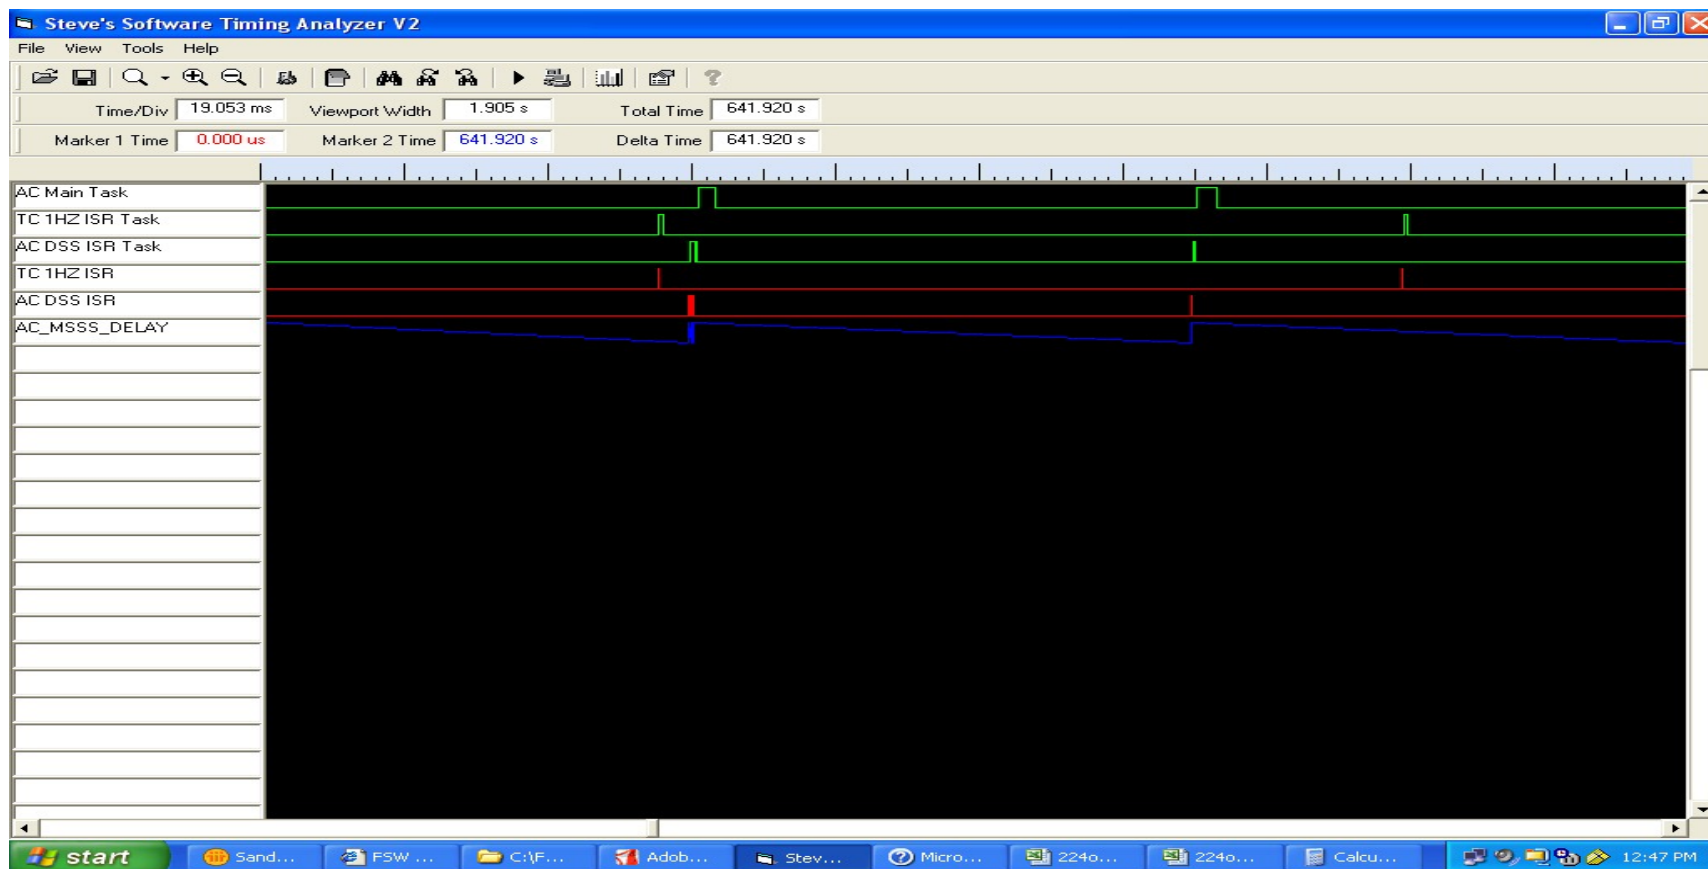
Timing Data Example

Spurious pulse precedes real pulse by about 0.66 seconds

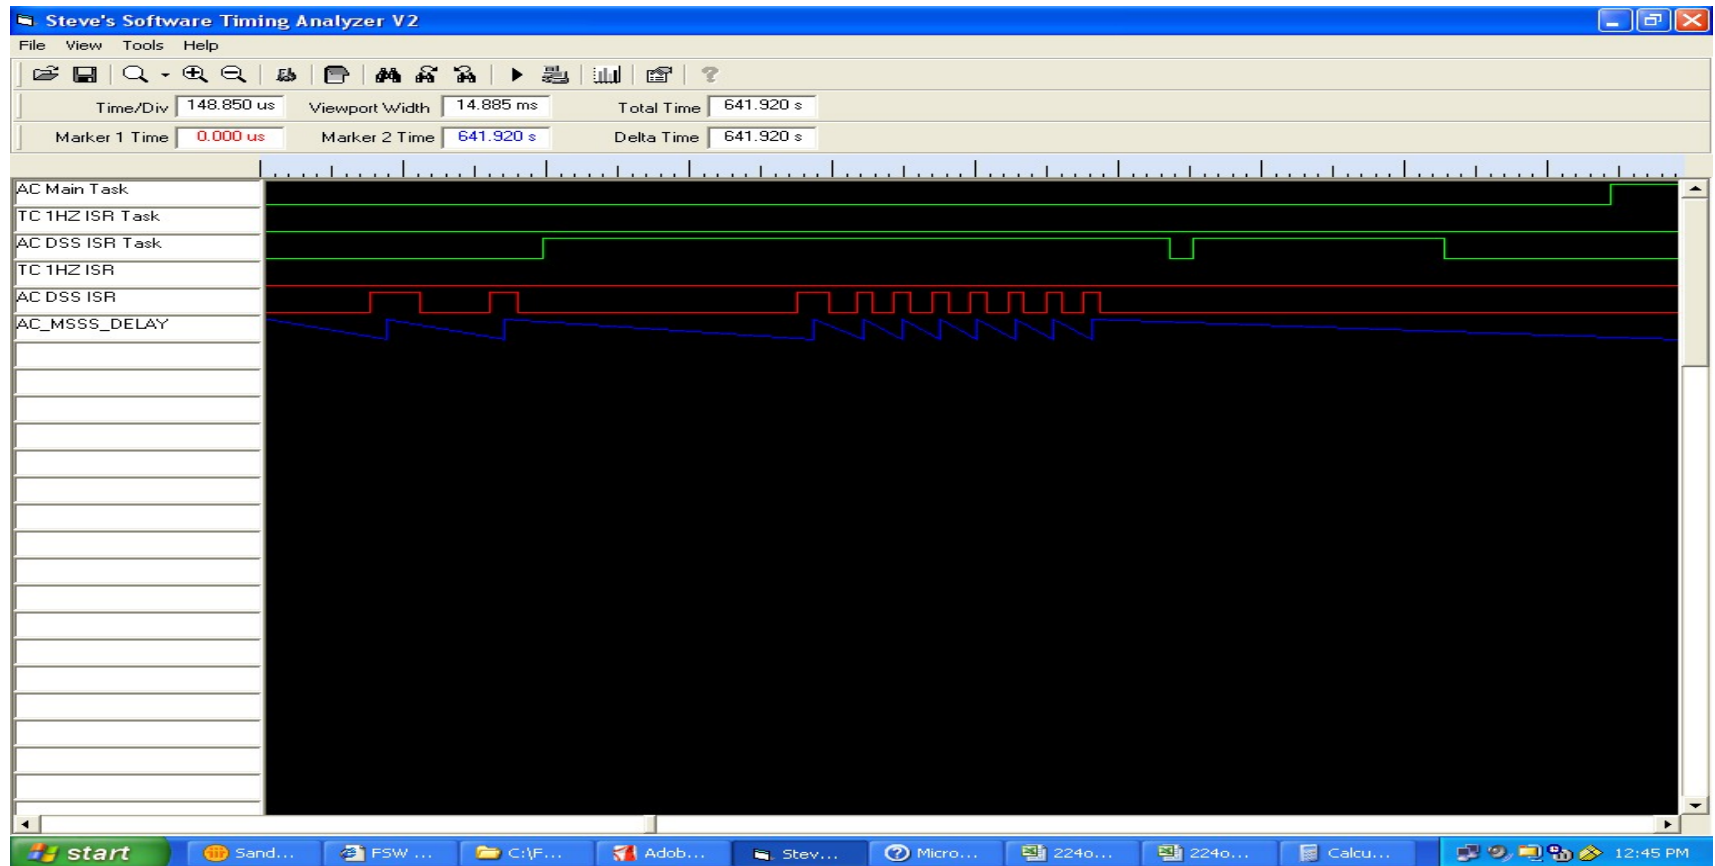
Zoom View of Spurious Pulse from Previous Plot

This spurious pulse consists of 10 separate flashes over 7.9 msec

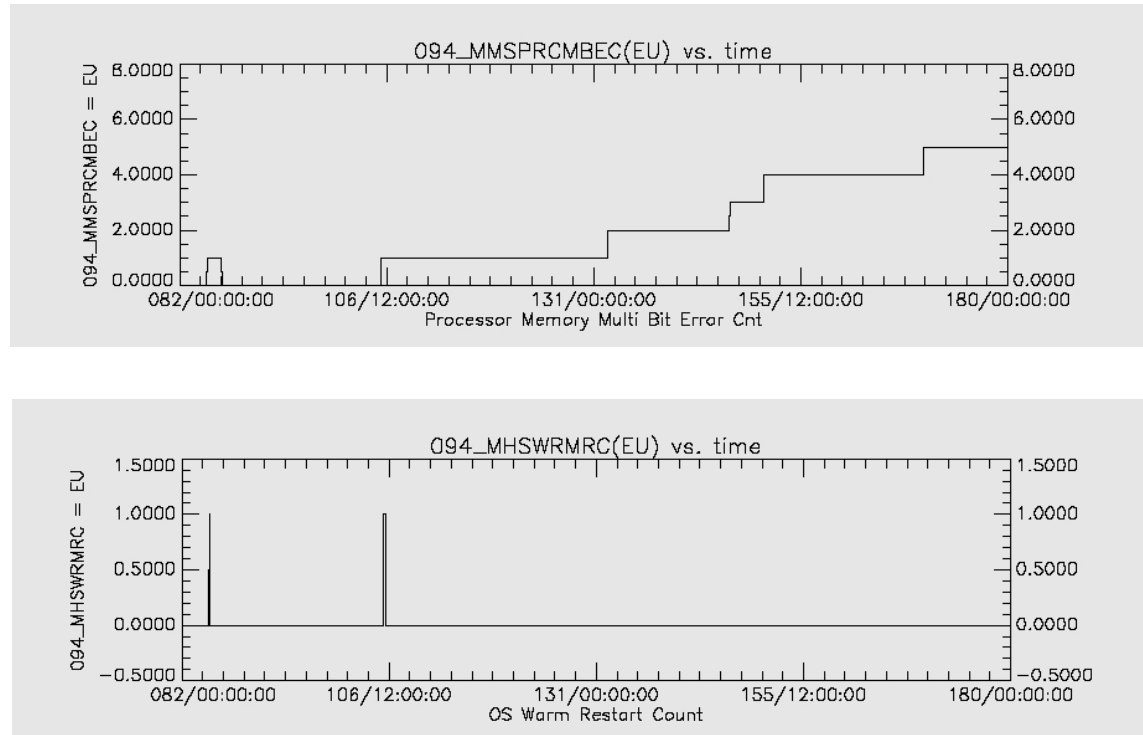
Processor MBE and warm restart counts, spacecraft 094

Spacecraft 094 experience soft power-on on DOY 89; MS table was updated on DOY 117

- ST5 spacecraft orbited through Van Allen belt
 - MBEs in recorder and processor RAM were frequent
 - Warm restarts required reloading of FSW patches
- Memory Scrub task response to MBE specified by a parameter table
 - Address ranges identified as “processor” or “recorder”
 - MBE action specified as “restart” or “no restart”
- FSW code and data occupied only 21% of processor memory
- FSW team suggested modifying MS table to flag unused processor memory as “no restart”
 - Should reduce occurrence of warm restarts by factor of 5
 - Table change uplinked to spacecraft on L+34

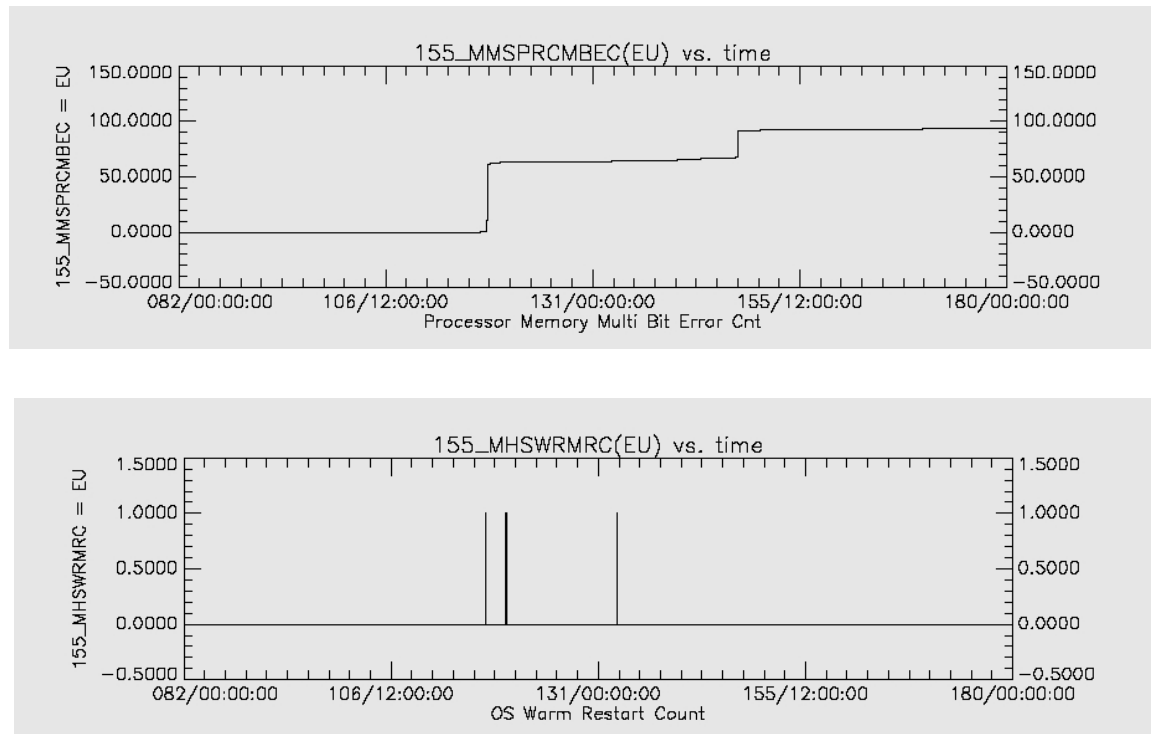
Processor MBE and warm restart counts, spacecraft 155

MS table was updated on DOY 117

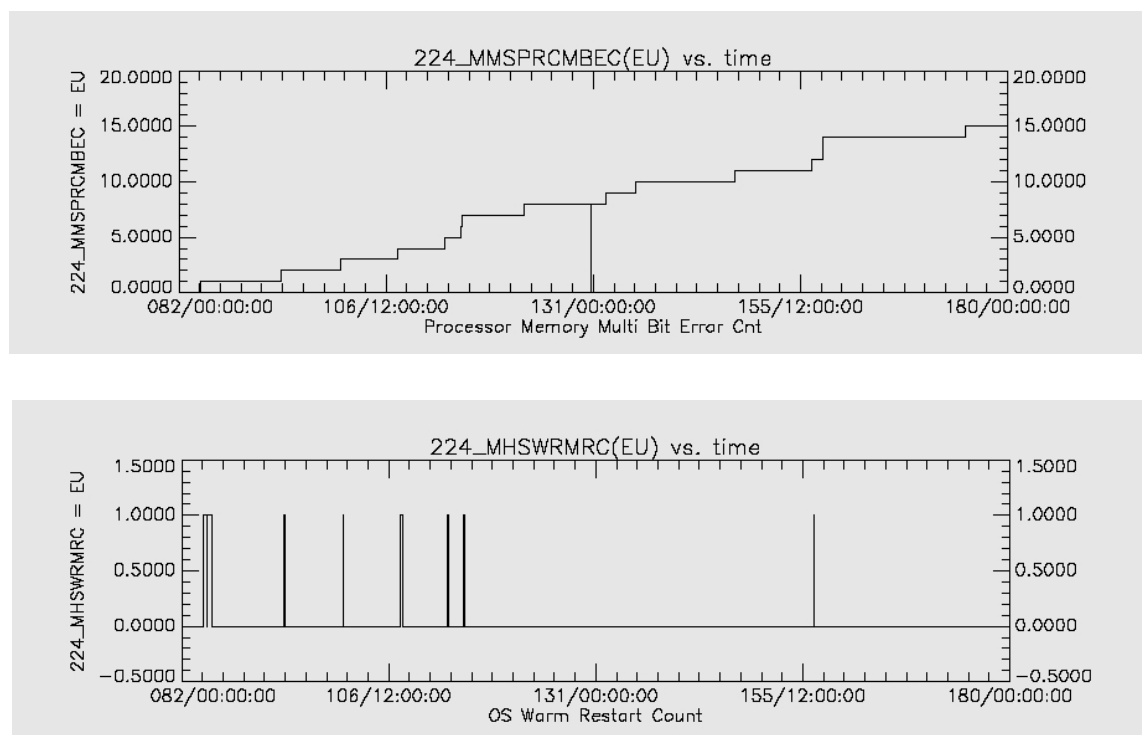
Processor MBE and warm restart counts, spacecraft 224

MS table was updated on DOY 117
